**MIDDLETON OLD TOWN HALL
EXISTING CONDITIONS ASSESSMENT**

REVISED May 16, 2013

PART 2: EXISTING CONDITIONS ASSESSMENT

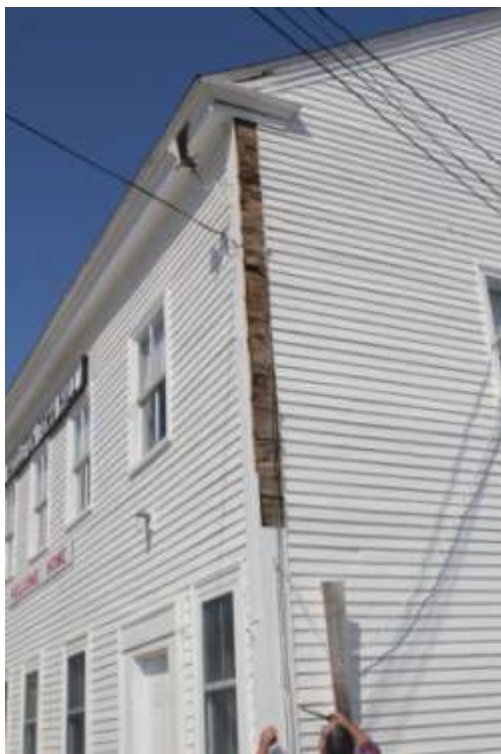
Photo 4: Corner board removed (roughly) by phone company

In 2012, the phone company removed a corner board on the southeastern corner of the building (Photo 4). Currently, the original sheathing is exposed, and the corner board ought to be replaced in kind.

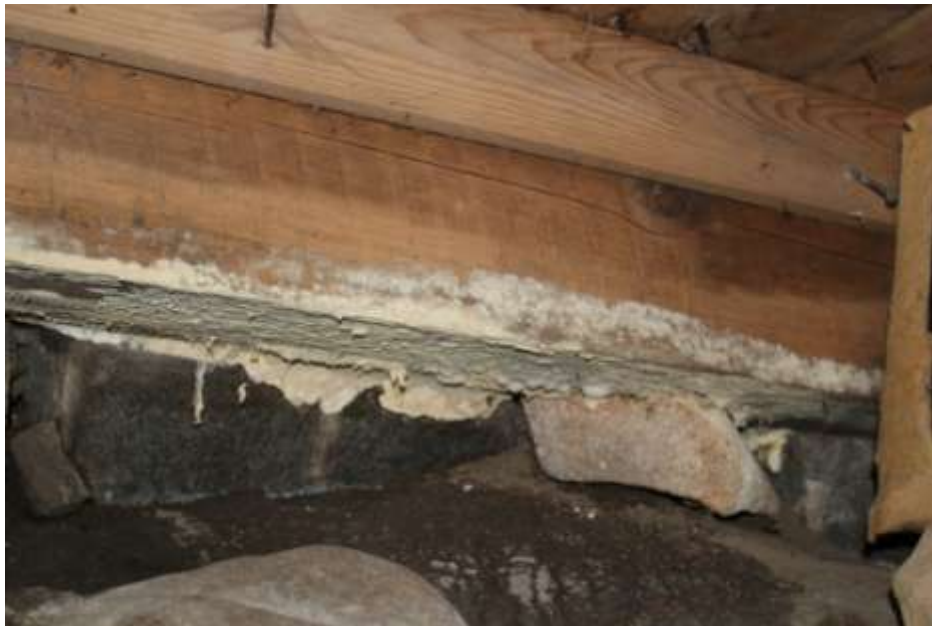
Photo 5: White mold on sill

One carrying timber, in Bent Five (Part 4.5, p.10) has been replaced by pressure-treated 2x10s, and many of the half-round timbers have been replaced by milled 4x6s. The front eave sill (Part 4.5 p.12), has been repaired multiple times, and is now composed of a patchwork of timbers that show no evidence of any tension connections, much less appropriate joinery. All of the carrying timbers, including the pressure-treated replacement, and many of the floor joists are showing signs of white mold (Photo 5).

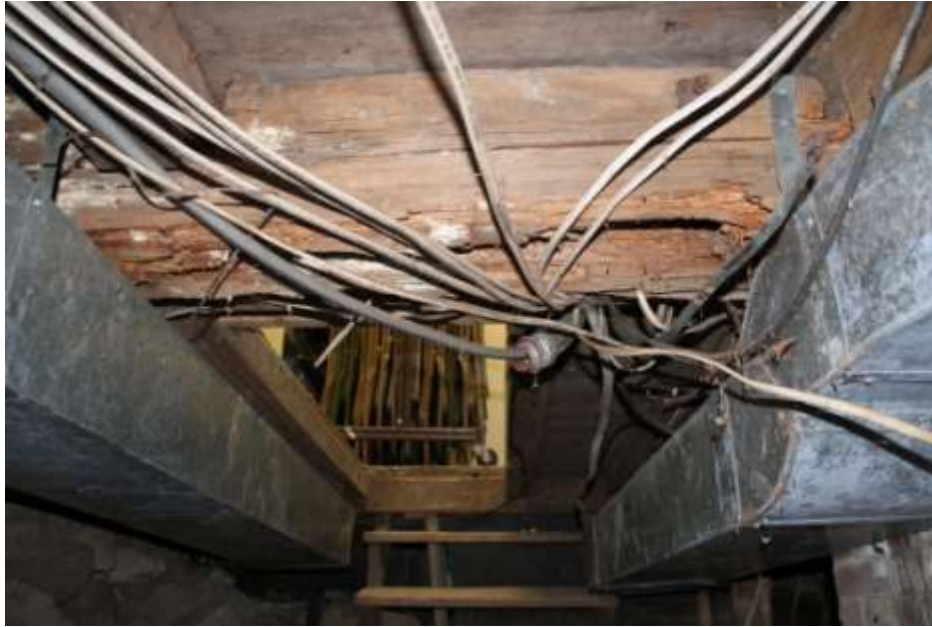
Photo 6: Rotten sill, Bent Six

Rot has claimed the sill in Bent Six (Part 4.5, p.11), and the sill is crumbling at the site of the basement hatch (Photo 6). White mold has rotted the front halves of the carrying timbers in Bents Two, Three and Four (Photo 7, 8). Serious mold deterioration has been observed in the north sill between Bents Four and Five. Mold has been observed on many of the joists that we could see, but most of the joists are obscured by insulation, especially in the Bay between Bents One and Two (Part 4.5, p.14). For this reason, even though we were able to observe extensive mold damage, we do not believe we saw all of it, specifically in the sill of Bent One. Unfortunately, insulation between the joists, tight to the floor, can contribute to damage of the floor frame. By restricting air flow, the insulation captures moisture directly against the frame, and creates the ideal environment for white mold and other causes of rot. We recommend instead insulating the ground and foundation walls, and lining with a moisture barrier. We also recommend installing a fan to control air circulation. A fan is often more energy efficient than an open vent in the foundation wall, because you can use a humidity sensor to turn the fan on and off automatically, and can better control heat loss.

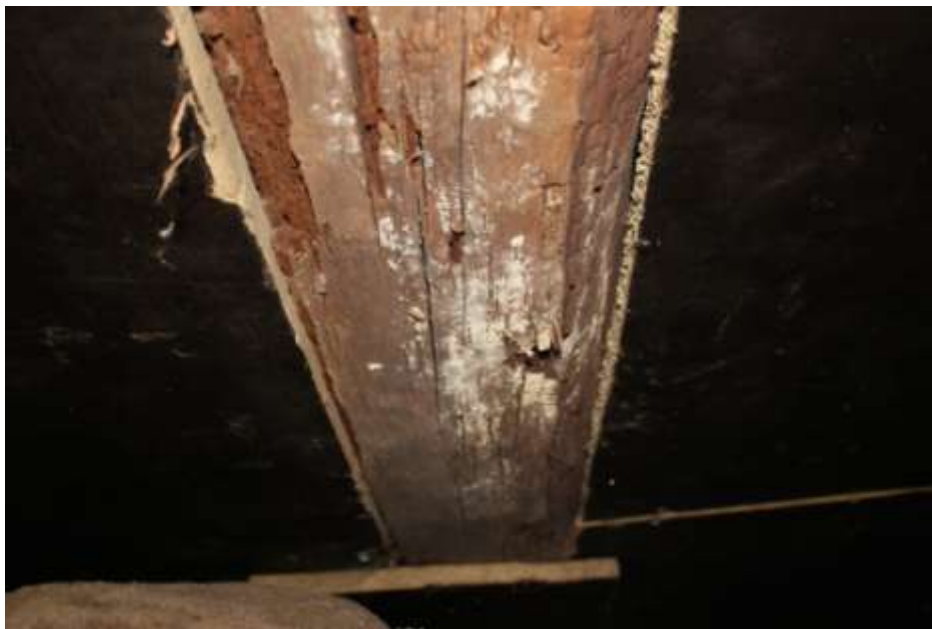
Photo 7: White mold and rot on carrying timber

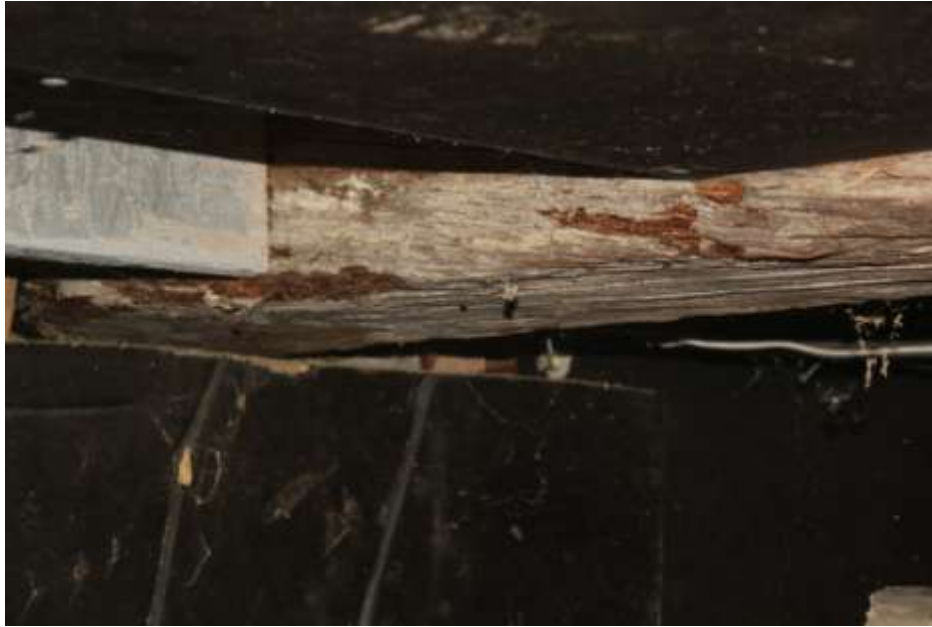
Photo 8: White mold and rot on carrying timber

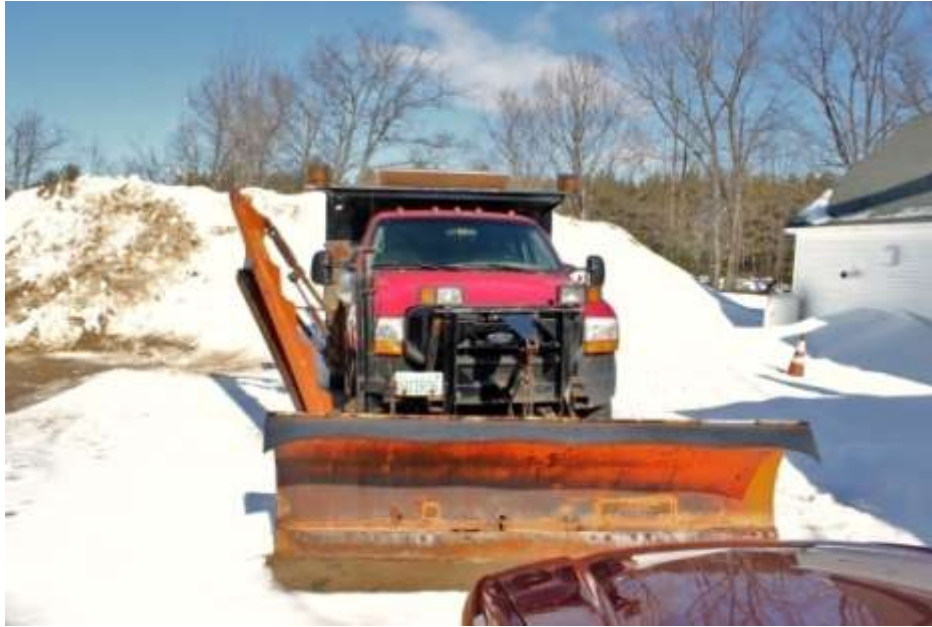
Photo 9: Plow and snow bank adjacent building

We did not observe any forms of functional drainage around or under the building. The expanse of asphalt and its proximity to the building, in addition to the poorly vented concrete block building, do not allow rainwater and snowmelt to drain away from the building. The only source of ventilation was where a large piece of the granite foundation had fallen into the basement, a blessing in disguise. Additionally, the snowmelt created by the proximity of the yearly plow pile is not helping matters (Photo 9). This lack of ventilation and drainage is causing moisture to accumulate in the basement, and accelerating the spread of white mold.

In order to improve drainage, the asphalt abutting the building ought to be removed to a minimum distance of 6 ft, and the landscape re-graded to direct water away from the crawl space. Re-grading plans should be reviewed by an archaeologist and follow the Secretary of the Interior's Guidelines for the Treatment of Historic Properties. Artifacts found within the re-grading area should be documented and removed. The establishment of proper drainage is integral to the survival of this building.

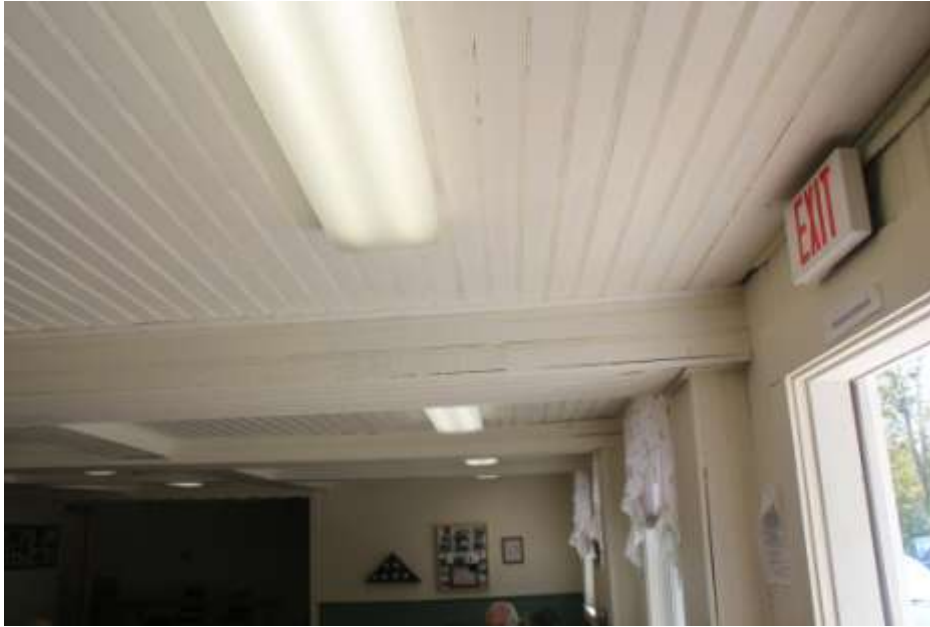
Photo 12: First floor tie beams sagging, opening joints in beadboard.

These first floor tie beams, and summer beams are sagging visibly (Photo 12). In the past, temporary posts were employed when there were functions upstairs, but without removing the beadboard, it is difficult to tell whether these temporary posts were properly engaged with the framing. There is a single center post at Bent Five (Part 4.5, p.10). Given the span and performance stage, we recommend that this post be replaced by two posts, and that similar posts be installed beneath second floor girts in Bents Three (Part 4.5, p.8) and Four (Part 4.5, p.9).

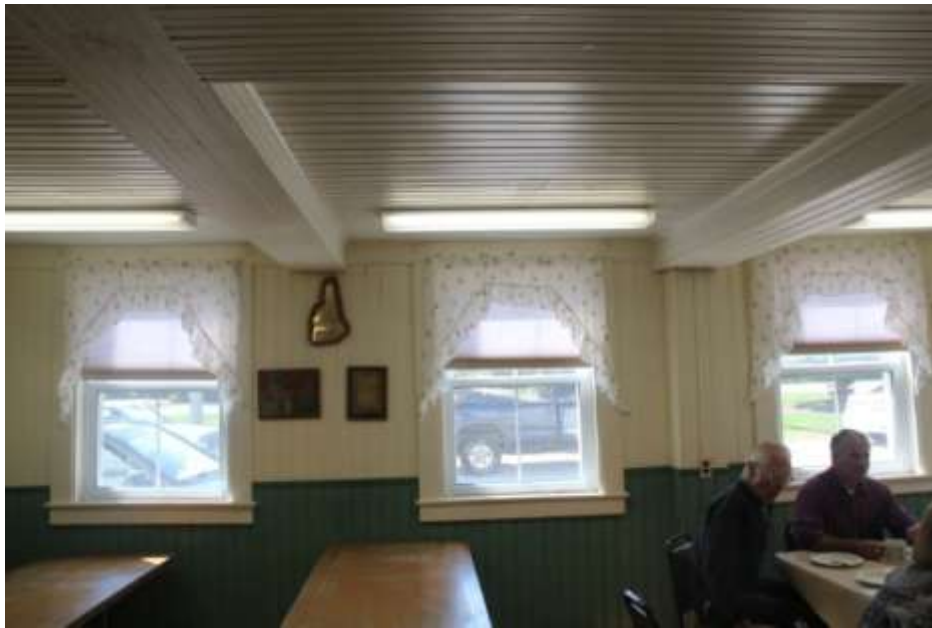
Photo 14: South post in Bent 3 is hacked back or missing entirely

The post on the south end of Bent Three is either missing, replaced, or has been hacked back (Part 4.5, p.8, Photo 14). Given the direction of cracking in the mural, the south post in Bent Four (Part 4.5, p.9) is probably also deteriorated in some way and may need repair. Given the condition of the south sill, it is likely that it will need a foot repair. The section of original meetinghouse sill that runs above these posts may also be deteriorated in some way, causing a gradual sag in the second floor (Part 4.5, p.12). Currently, it is impossible to inspect without removing flooring, ceiling or sheathing, but it ought to be inspected during Phase 2 (Part 3.2) of the repair process.

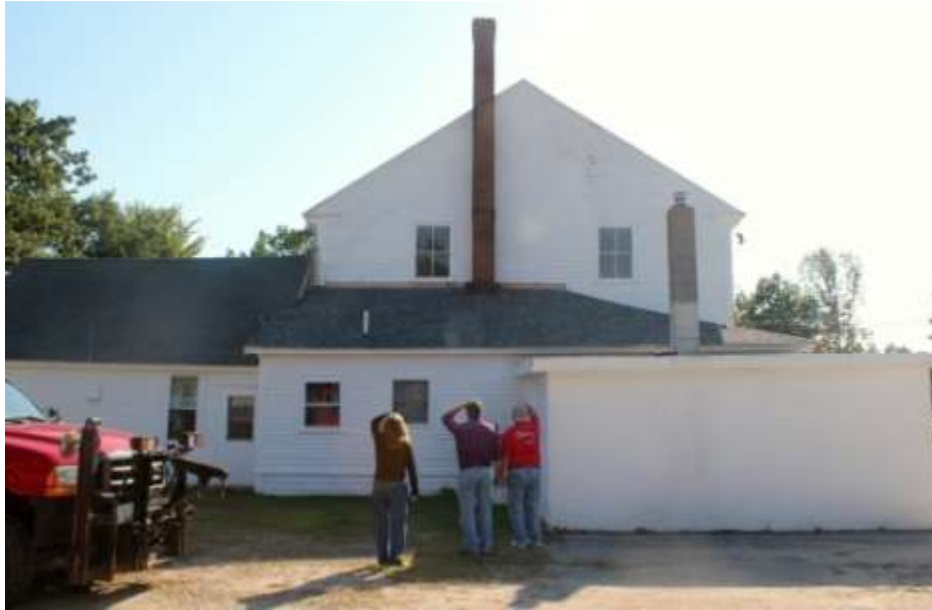
Photo 16: West Gable, with concrete vault in foreground

A concrete vault was added to the west gable in the mid-1900s in order to house town documents (Photo 16). These documents are no longer stored there, and the vault now mostly stores moisture and mold spores. Built well after this building's period of historical significance, the concrete vault was an unfortunate addition to this historic property. Its design and construction in no way emulates a building that has long served as a center of the community. But the building's negative impact is far more than aesthetic. The flat roof collects run-off from the bathroom addition, and moisture condenses and accretes on the concrete block. The lack of ventilation, in combination with poor drainage, is at the root of the white mold problem in the building's undercarriage.

Lastly, I want to reiterate that, due to the mold problem, retaining the concrete addition will have a negative effect on the rest of the building, not a neutral one. It ought to be measured, photographed thoroughly and carefully demolished to prevent damage to the adjacent structure and any hidden artifacts.

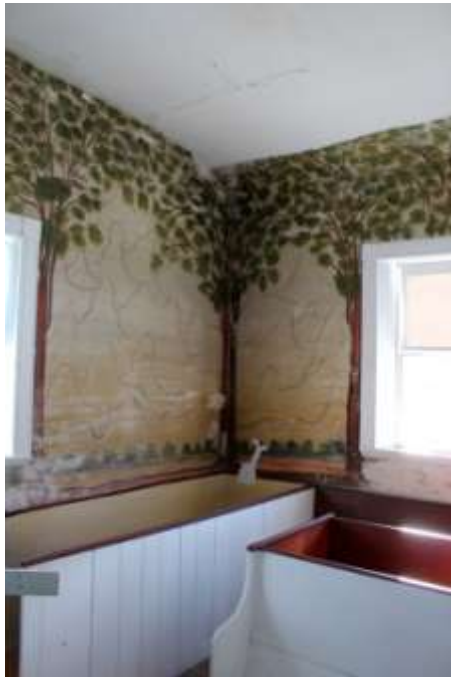
Photo 19: Mural, northeast corner

The first priority in the preservation of this building is the meetinghouse interior, including the mural and box pews. The skim coat of the mural is delaminating in a few places, and needs to be re-adhered before the building is manipulated (Photo 19). There are also larger cracks in the mural that extend through the brown coat, and are the result of structural settling. From what we could observe without more invasive inspection, this damage is due to deterioration of the sills, and subsequent deterioration of the posts.

The cracks due to structural settling should be stabilized before manipulating the building, as outlined in Tony Castro's report. During the leveling process, the cracks should be observed through a viewing panel. In this way, the mural and plaster can serve as controls for manipulating the building.

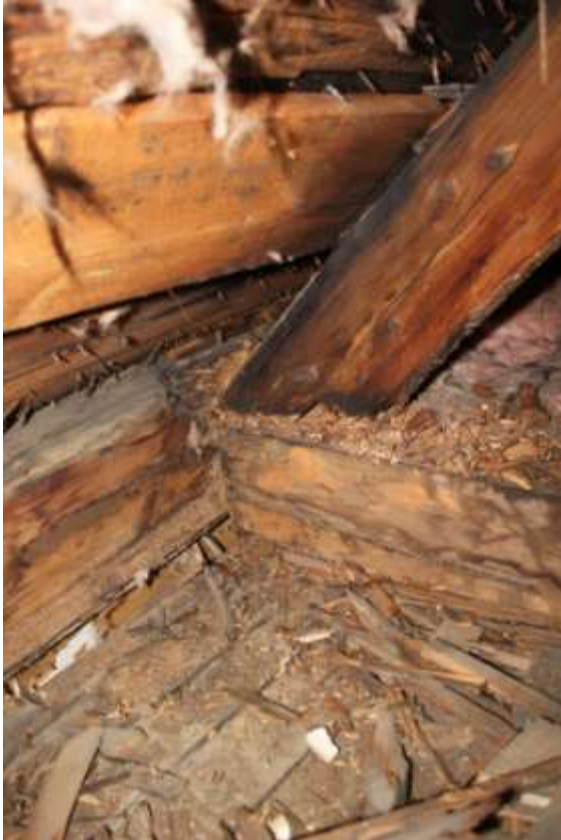
Photo 33: Tie beam 3, end rotten and severed from west schoolhouse plate

The end of ceiling joist/tie beam three is severed, and has dropped well below the top of the plate (pp 25-26, Photo 33). The plate and rafter heel are similarly rotten. This damage was likely due to a roof leak, and possibly exacerbated by overloading of the tie beams. Fortunately, the damage is localized.

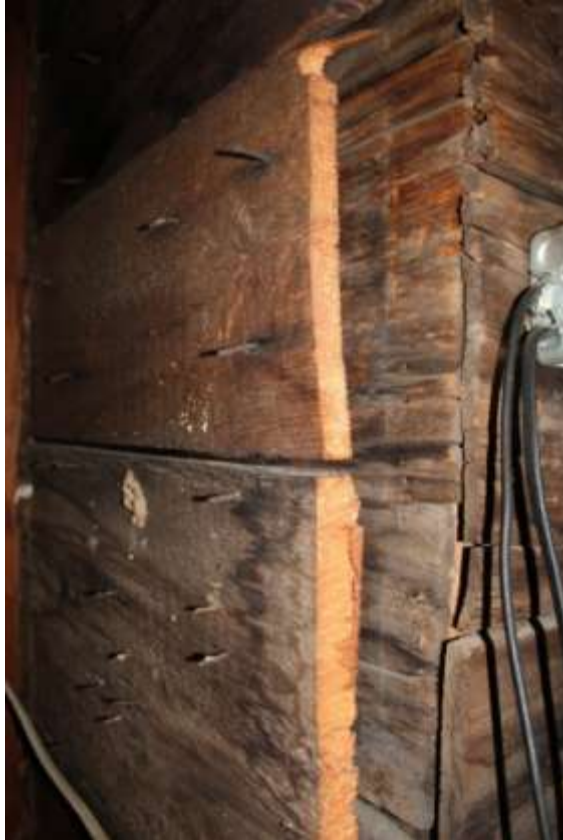
Photo 37: Gap between schoolhouse sheathing and northwest corner of the meetinghouse

During the repair process, the schoolhouse may need to be disengaged from the main meetinghouse. Fortunately, there is a wide gap between the exterior sheathing of the school house and the meetinghouse sheathing (Photo 37). The spread is as wide as 6 inches at the Schoolhouse tie level.

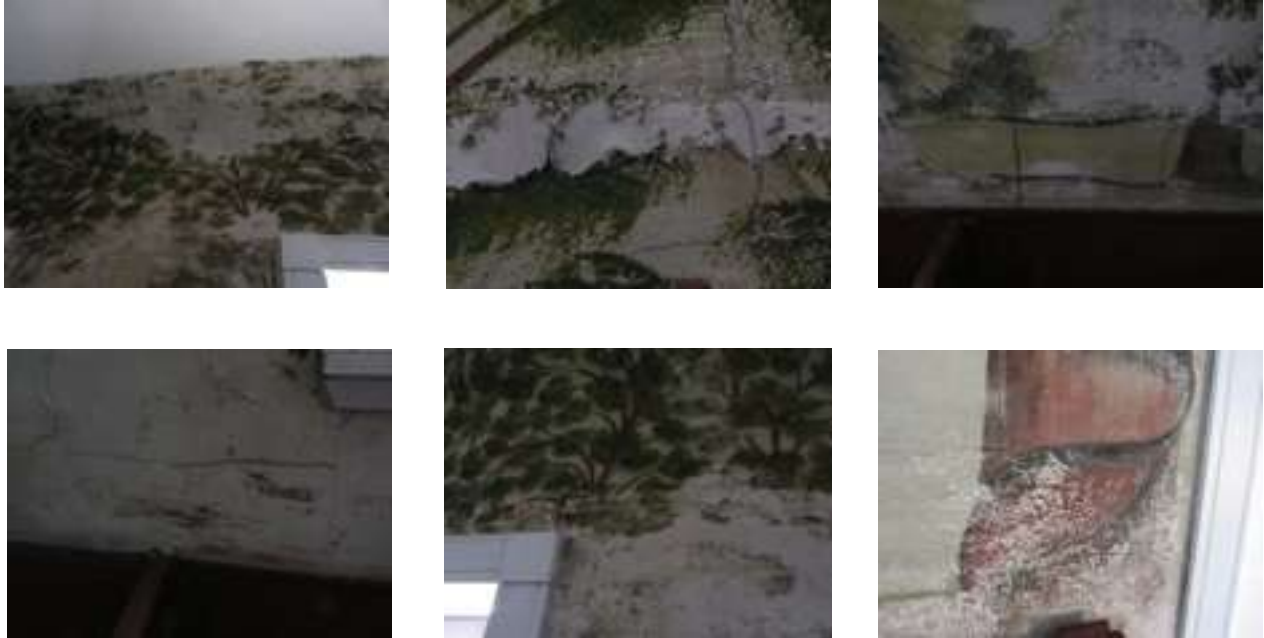
Illustrated above are several examples of the paint failure all of which can be attributed to moisture. Some have been a result of water infiltration due to leaks in the roof and possible ice dam situations. The bulk of the loss appears to be from atmospheric moisture resulting in condensation on the walls. Distemper paint is far more sensitive to this than most other paints. The same amount of moisture would not even be apparent on a modern painted surface. The absorbent nature of these old protein bound paints and subsequent breaking down of the binder leads to the type of failure that exists here.

Controlling the humidity in the building will be an important aspect to any plan to preserve the murals. The sources of this moisture are many. It begins with nature's help from above with rain and snow, and below from the soil, and all around from humid weather. It is added onto by cooking and human respiration. It has the greatest tendency to condense on the walls when the temperature of the plaster is significantly lower than the air temperature. Keeping the roof from leaking including adding ice and water shield for ice dams, moisture control in the crawl space against the soil including ventilation, exhaust fans whenever cooking, and a dehumidifier in the meeting house would all be beneficial. Warm moist air let in when windows are opened in the summer for ventilation tends to condense on the cold plaster overnight. Again, what would be a negligible amount of condensation on most surfaces is the long term demise of distemper paint. Because distemper is so absorbent you never even see the typical
