**MIDDLETON OLD TOWN HALL
EXISTING CONDITIONS ASSESSMENT**

REVISED May 16, 2013

PART 2: EXISTING CONDITIONS ASSESSMENT

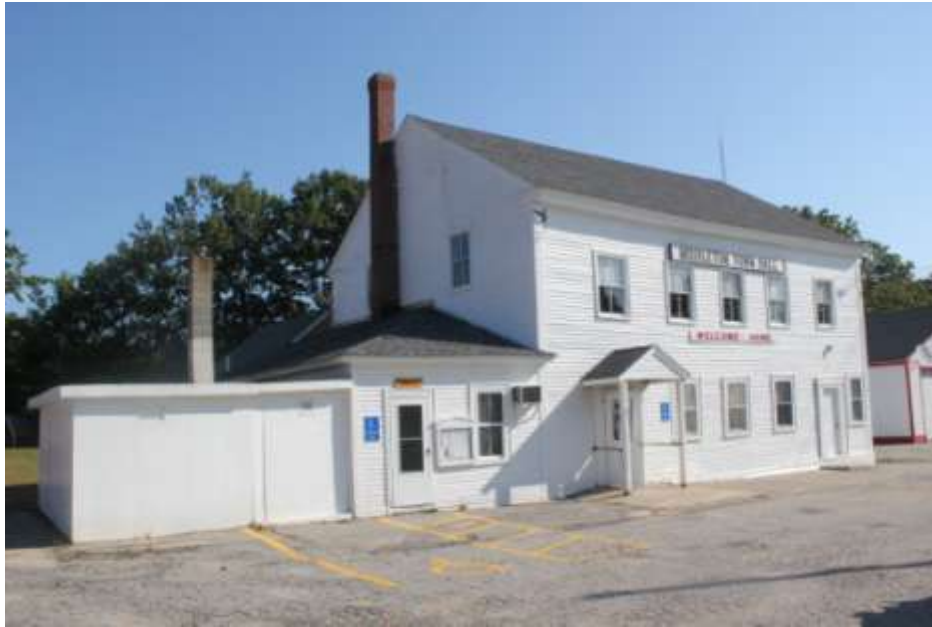
Photo 3: Middleton Old Town Hall September 2012

Overall, exterior siding and trim appears to be well-maintained (Photo 3). Raking fascia, crown, and returns are consistent with vernacular trends of the early 1800s, when the meetinghouse was moved. The gabled door canopy over the main entrance is not consistent with this style and is not visible in the photo from 1907. Currently, however, the canopy protects an entrance ramp which allows access by visitors with limited mobility and ought to be retained.

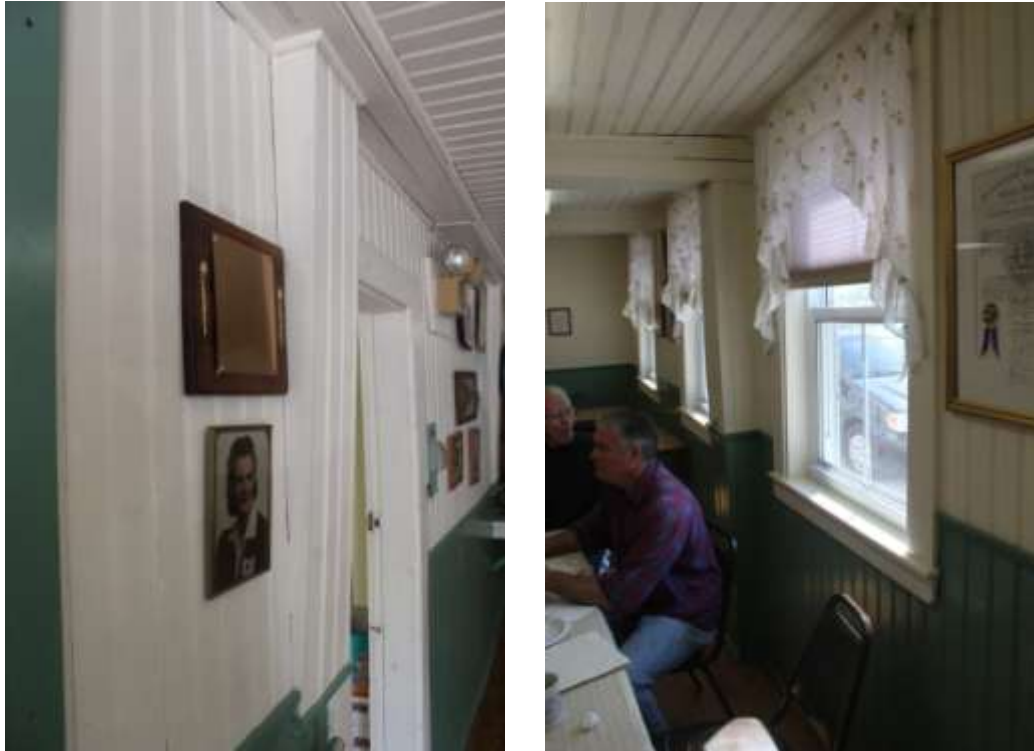
Photo 10 and Photo 11 Tapered gunstock posts in banquet hall, encased in beadboard.

Tapered gunstock posts line the south, west and north walls of the banquet hall (Photos 10, 11). Gunstock posts are typical of 18th and early 19th century timber framing, and are specifically used in conjunction with the English tying joint of that period. These posts are characterized by their taper from top to bottom, the additional material at the top accommodating the complex joinery where the post connects to both plate and tie beam. In each bent is a pair of gunstock posts that are connected by a tie beam that runs from eave to eave. These tie beams support the original meetinghouse floor, and, like the posts, are cased in beadboard. The ties vary in width, but even the narrowest appears to be 11 ½" wide. Two summer beams, or what may be truncated summer beams, run above these ties. It is unclear what their dimensions are, but given the size of the casing, they appear to be wide, upwards of 12 inches, and relatively short, fewer than 7 inches. The bent drawings, and second floor framing drawings, reflect our best conjecture of this configuration (Part 4.5, pp. 6-11, 15). More invasive investigation will be required during repair Phase II (Part 3.2) in order to confirm joinery between first floor posts, first floor tie beams and original meetinghouse undercarriage.

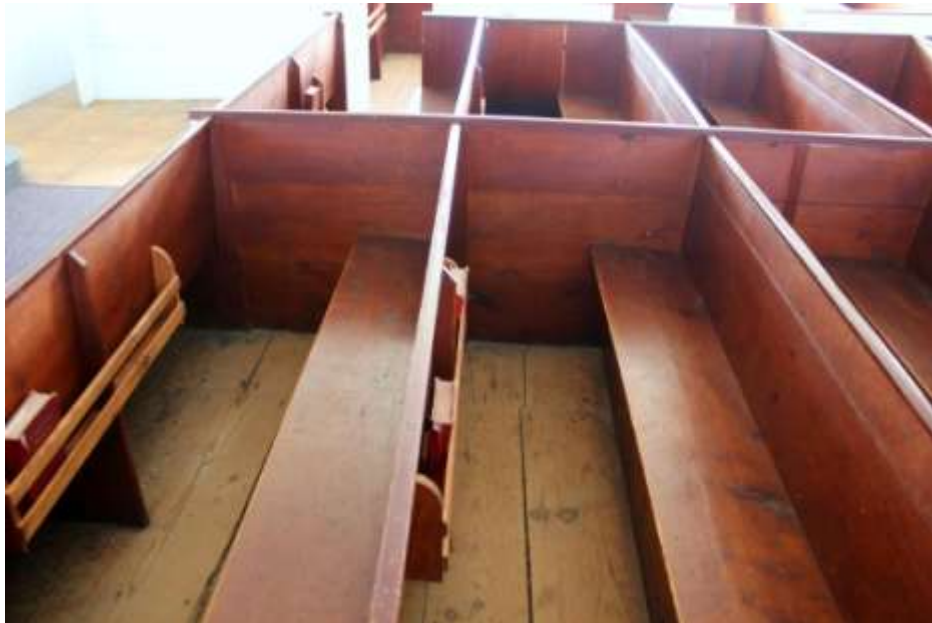
Photo 13: Box Pews and sanctuary floorboards

Floor joist layout of the second floor/original meetinghouse was determined by examining floorboard nailing (Photo 13). Floor joists are 6 ½" x 6 ½" laid out 3' on center.

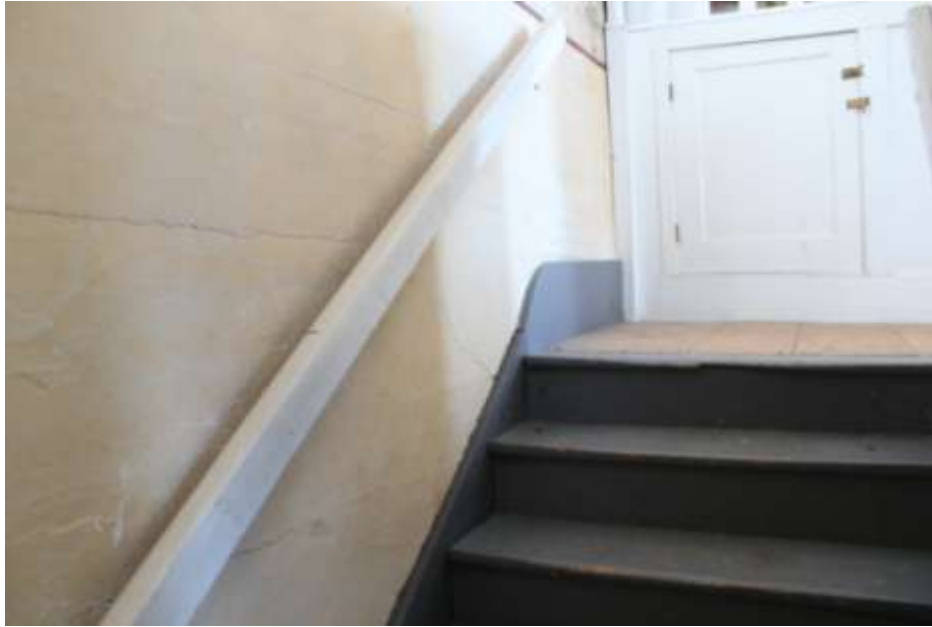
Photo 15: Existing meetinghouse stairs on west eave wall. Note change in pitch of baseboard from stairs to second floor.

There is evidence for a second staircase upstairs in a truncated baseboard to the south of the front podium. When the meetinghouse was moved it appears that they installed symmetrical staircases on either side of the podium. The angle of the remaining baseboard indicates that the stairs used to be much steeper (Photo 15). In order to comply with contemporary building code, a second egress will need to be added to the meetinghouse. It would be historically appropriate to place them in the Southeast corner where there were stairs originally. In order for the stairs themselves to comply, they will need to make at least one turn, similar in layout to the existing stairs.

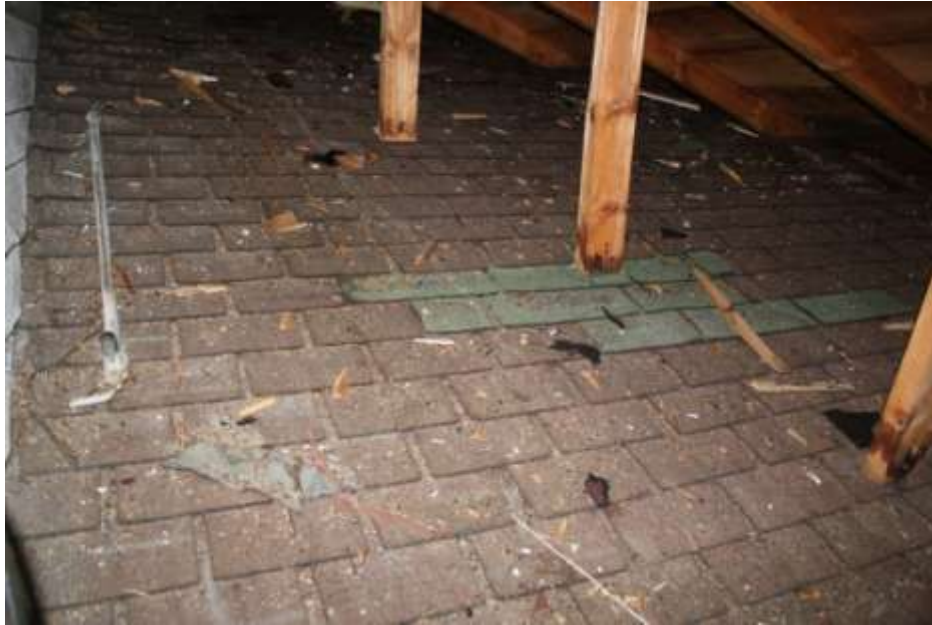
Photo 17: Bathroom addition roof, from schoolhouse attic

The building originally had a hip roof, and in 1950, when the Corner School was added to the rear of the property, a shed roof extension was built on top of the back pitch of the hip roof (Photo 17). The hip roof appears to have been built directly onto the sheathing of the main meetinghouse.

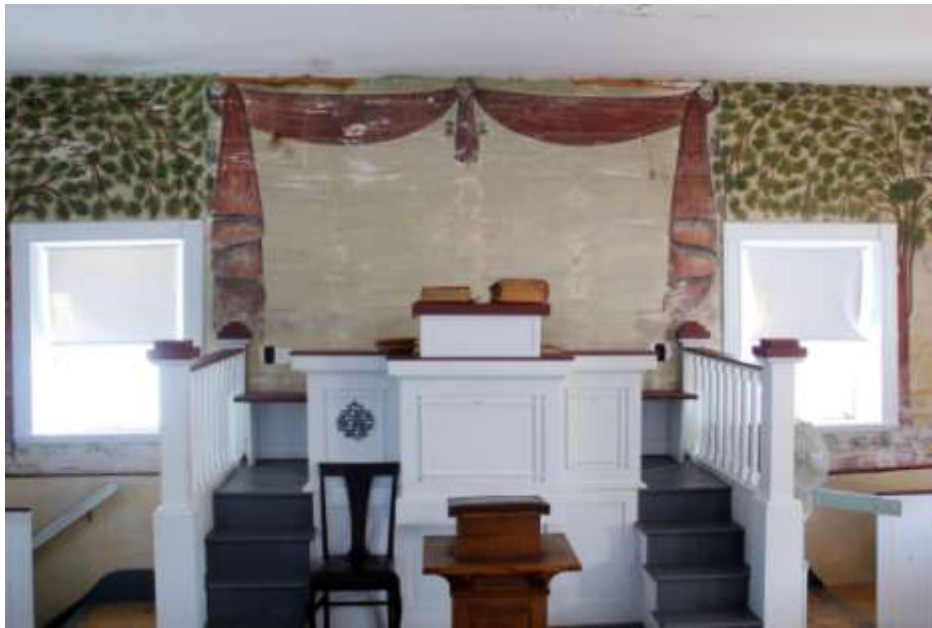
Photo 18: Meetinghouse podium, and mural, painted by John Avery, in 1841

The first priority in the preservation of this building is the meetinghouse interior, including the mural and box pews. The skim coat of the mural is delaminating in a few places, and needs to be re-adhered before the building is manipulated (Photo 19). There are also larger cracks in the mural that extend through the brown coat, and are the result of structural settling. From what we could observe without more invasive inspection, this damage is due to deterioration of the sills, and subsequent deterioration of the posts.

The cracks due to structural settling should be stabilized before manipulating the building, as outlined in Tony Castro's report. During the leveling process, the cracks should be observed through a viewing panel. In this way, the mural and plaster can serve as controls for manipulating the building.

After the mural is stabilized, a water level should be used to determine the precise amount of sag at each level of the building -- first floor, meetinghouse floor and attic -- as well as at each bent. We recommend that the meetinghouse be leveled from the original meetinghouse sill, effectively lifting and supporting the second floor from the same place as when the building was originally moved. This will allow full access to the undercarriage framing and post feet once flooring in the banquet hall is removed. When lifting or leveling, special attention will be paid to supporting the plate, and straightening any sag at the same time, in order to prevent compression of the mural. This can be accomplished by placing ledger and brackets along both the second floor sill and the top plate, and connecting the two with strong-backs laid out along the posts. A full leveling plan can be developed after the first stabilization phase of repairs is completed, with a limited amount of more invasive investigation.

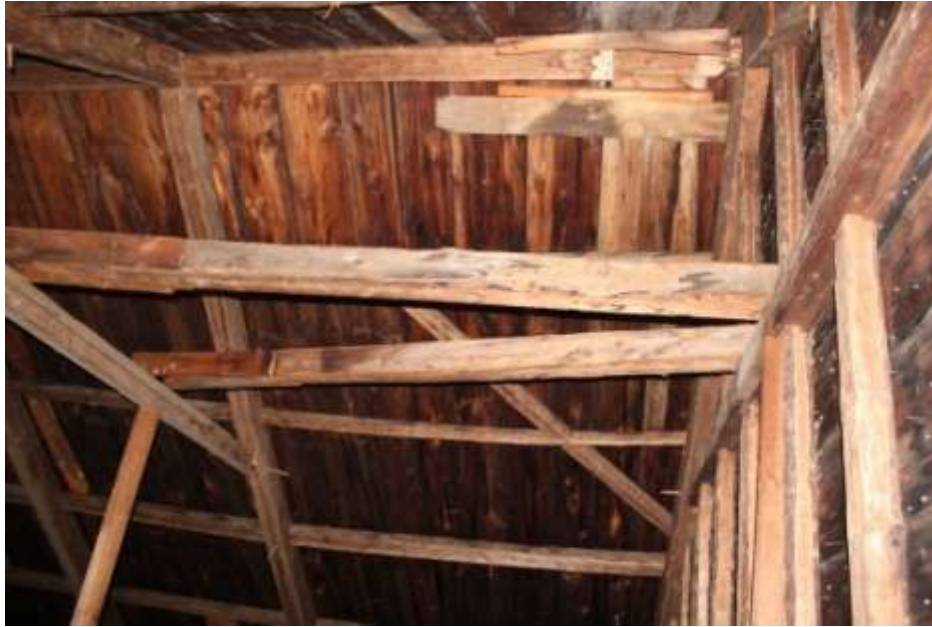
Photo 21: Wind brace in south roof pitch, adjacent Bent 6

Wind braces, located in the bays adjacent to both gables, have contributed to the long term stability of this roof system (Photo 21). Hewn collar ties support rafter pairs at their midpoint; they are nominally 5x6 inches, and joined to the rafter by pinned mortise and tenon.

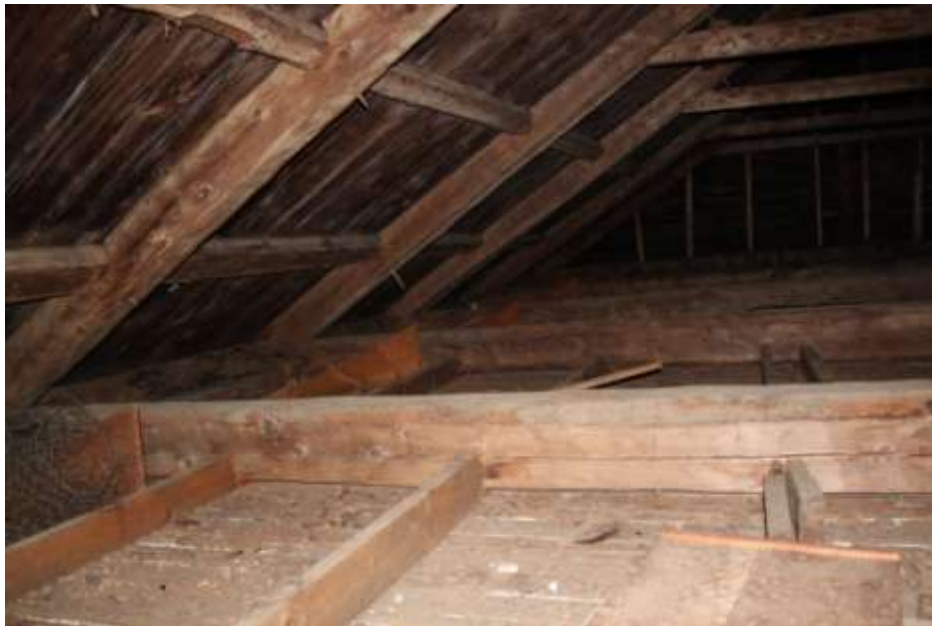
Photo 22: Oversized tie beam, 10" x 12"

In a building with an open span of 32 feet, it is unusual for the builder not to use some kind of truss system to support the tie beam, or bottom chord, across the open span. Here, the original builders employed an oversized tie beam, 10" x 12", to support its own weight across that distance (Photo 22).

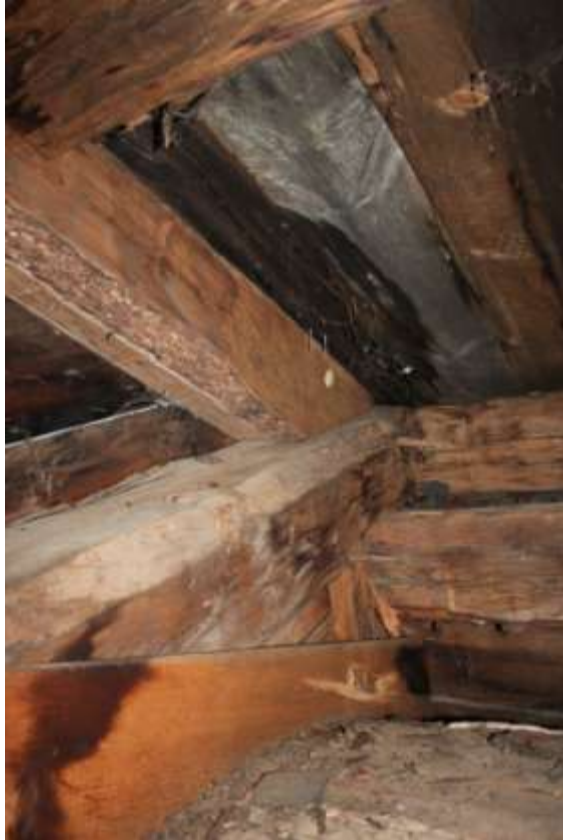
Photo 23: Tie beam, rafter and plate connection

The tie beams cog over the plates, 6" x 12", and extend past the plates by 10 inches. The ends of the ties are joined to flying purlins, 4" x 12", which run between the bents (Photo 23).

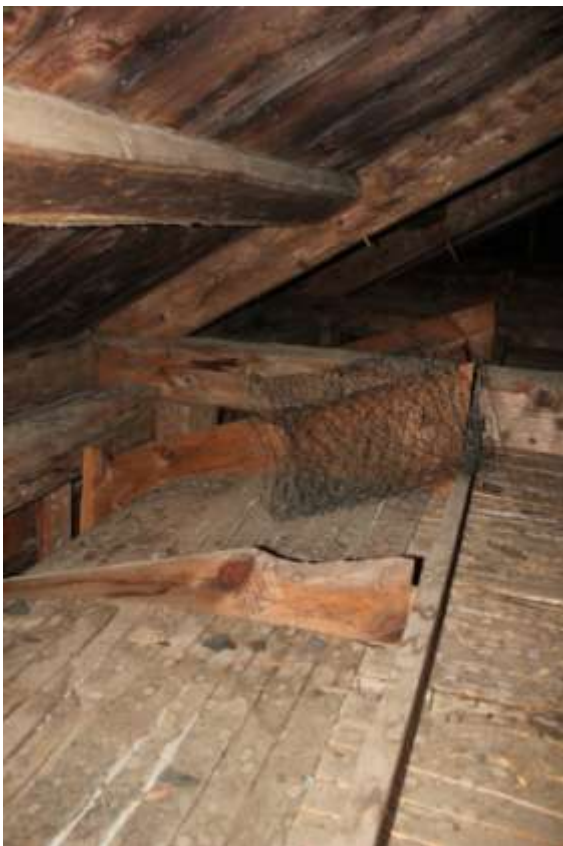
To a certain extent, the ribs creating the coved ceiling may have also provided secondary support and bracing (Photo 24, Part 4.5, p. 16). The ceiling is framed by a series of these ribs, 2" thick, approximately 4' on center which are nailed to ceiling joists, upright sawn, 2" x 6", 3' on center.

Given the span of the ties and joists, and the importance of the coved ceiling, I was not able to visually inspect each of the rafter-tie-plate joints. I did not see any leaks, or obvious deterioration. During the repair process, a plank should be threaded into the hatch, and used to walk down the eaves and inspect these joints.

Photo 24: Coped ceiling joists, or "ribs," which create the coved meetinghouse ceiling

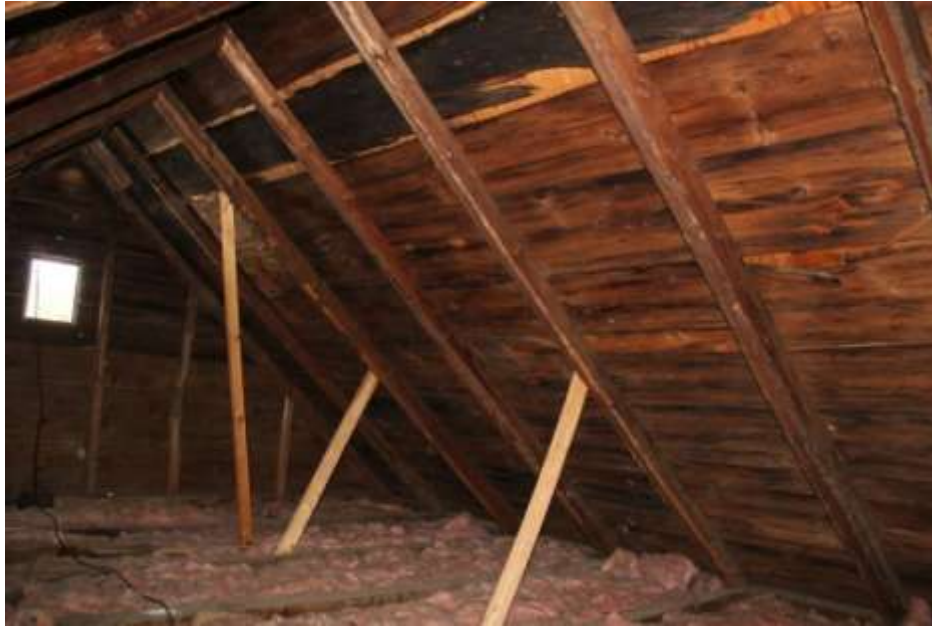
Photo 27: Schoolhouse roof framing

The schoolhouse roof is framed with a series of common rafters, 4"x 6" at the heel, tapering to 4"x 4" at the peak (Part 4.5, p.26, Photo 27). They are hand-hewn, but barely; nearly every rafter has at least two waney edges with the bark still attached. One can see how the natural taper of a tree was employed to give strength to the bottom of the rafter, and lightness to the top. Common rafter roofs were common in Connecticut in the 18th century, but came to Northern New England much later. It is unusual, and architecturally significant, to find a common rafter roof system that is completely hand hewn. The gable end studs are waney, like the rafters, nominally 3" x 3".

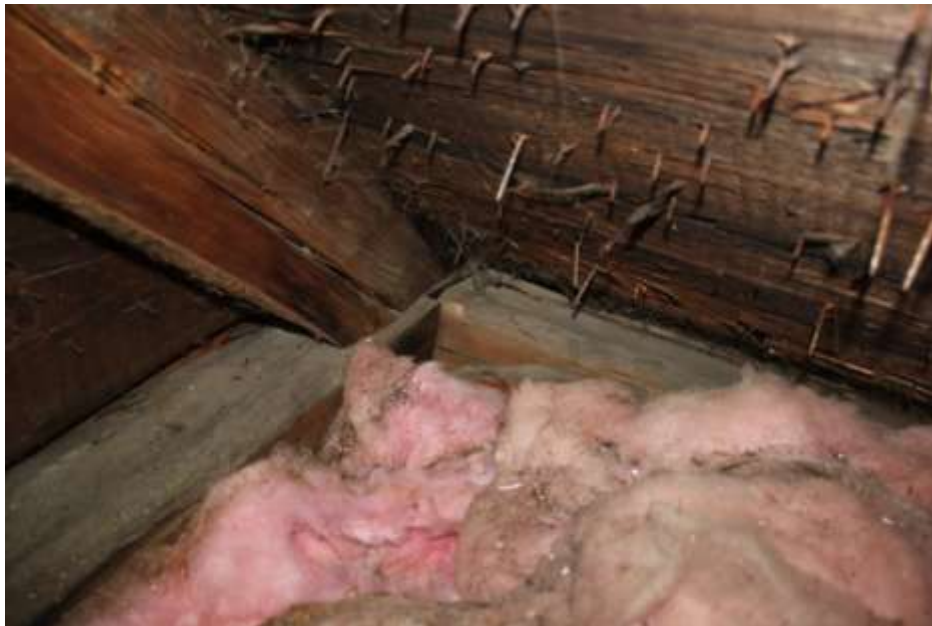
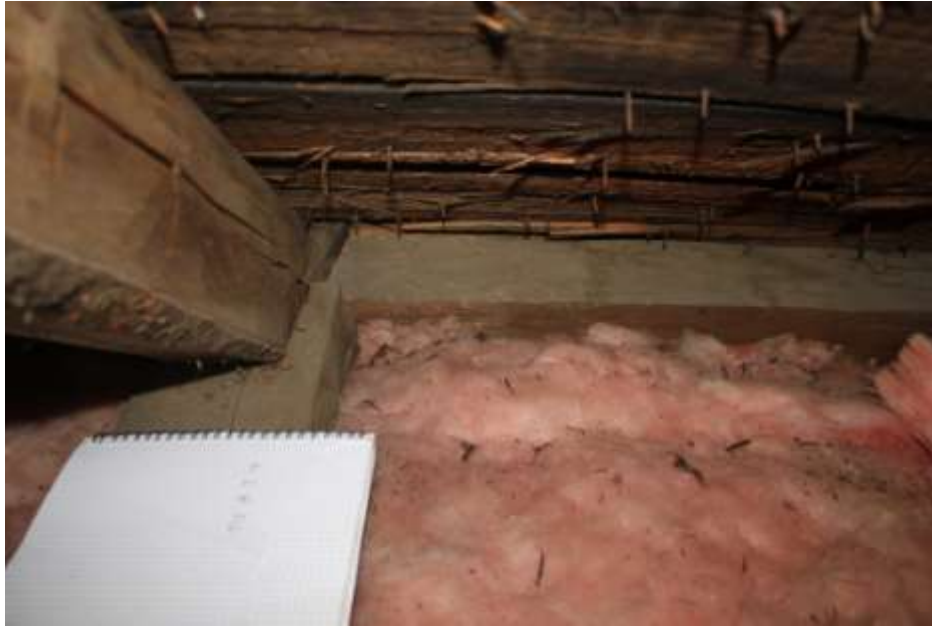
Photo 28: Schoolhouse tie beam-plate-rafter connection

Photo 29: Half dovetail on end of schoolhouse tie beam

The tie beams, ceiling joists and plates are also hand hewn, nominally 6" x 6" in dimension (Part 4.5, p.26). The tie beams and ceiling joists are cogg'd over the plate with a half dove-tail (Photos 28, 29). The half dovetail is a good tension connection that keeps the eave walls from spreading under the outward thrust of the rafters.

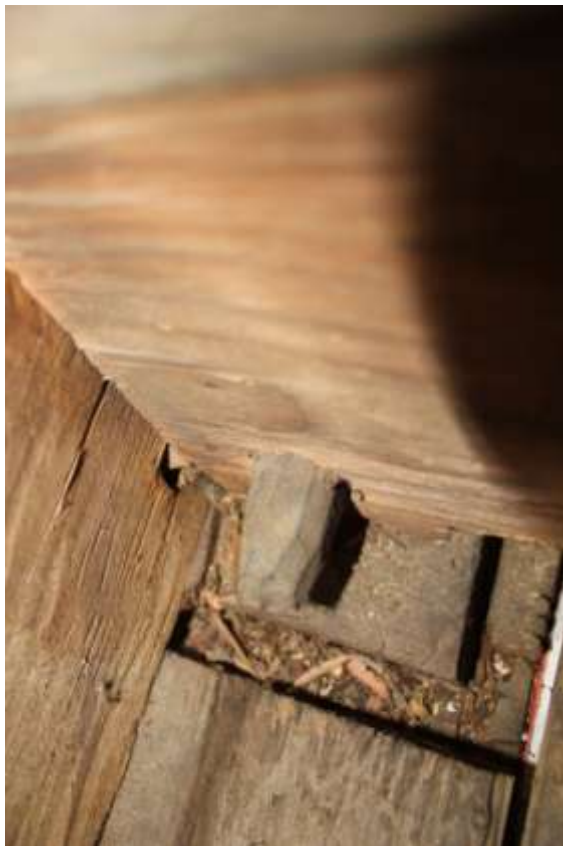
Photo 30: Shoulder of gunstock post, and teasel tenon pin

The gable tie beams are joined to gunstock post and plate with an English tying joint. At the inside of the gable corners, I was able to photograph a corner of the top of the gunstock posts and the end of the pin securing the teasel tenon (Photo 30). As stated above, the English tying joint is typical of the 18th and early 19th centuries. The development of this joint was integral to the longevity of timber-framed buildings in the Northeast and they are a significant architectural detail. The posts are 7" x 9" at the plate-tie level and probably taper to 7" x 7" at the sill.

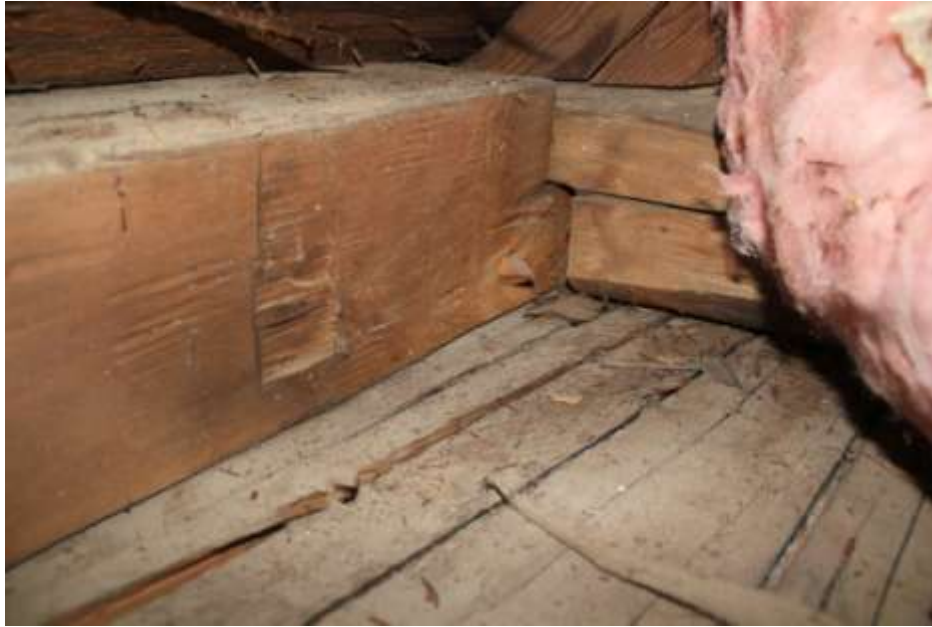
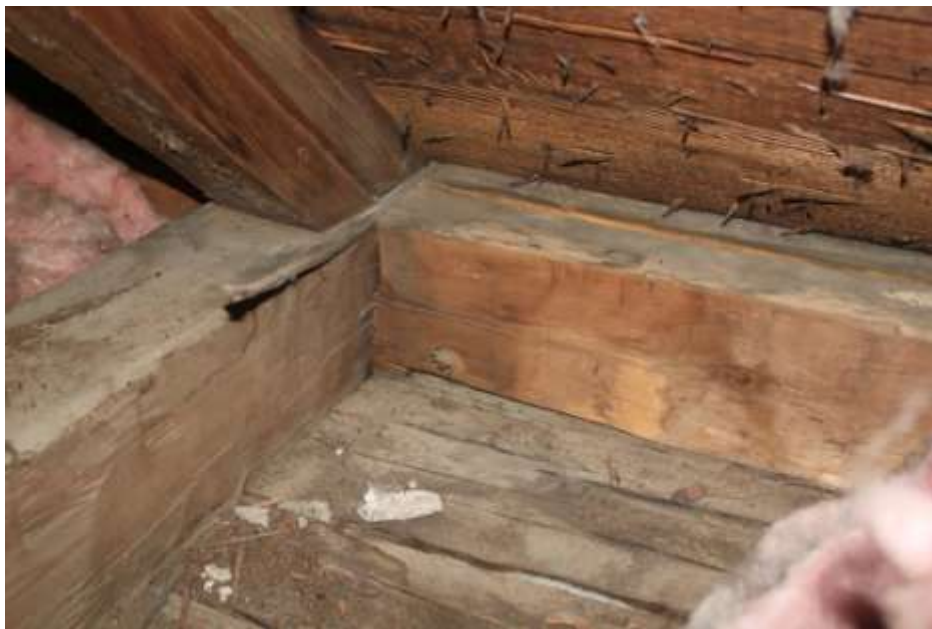
Photo 31: East schoolhouse plate, with pin at midspan

Photo 32: West schoolhouse plate, with pin at mid span

Unfortunately, mid-eave posts were better hidden. I was not able to observe the tops of any posts along the length of the plates, nor did I see any teasel pins in the central tie beams/ceiling joists. There are three pins in the east eave plate; it is likely that they secure the joinery of a straight 6"x6" post (Photo 31), a brace for that post, and a brace for the southeast corner post. There is a similarly laid pin at the center of the south plate (Photo 32). The joist bays are well-insulated, and we suspect that there are additional brace pins 42" from each corner.

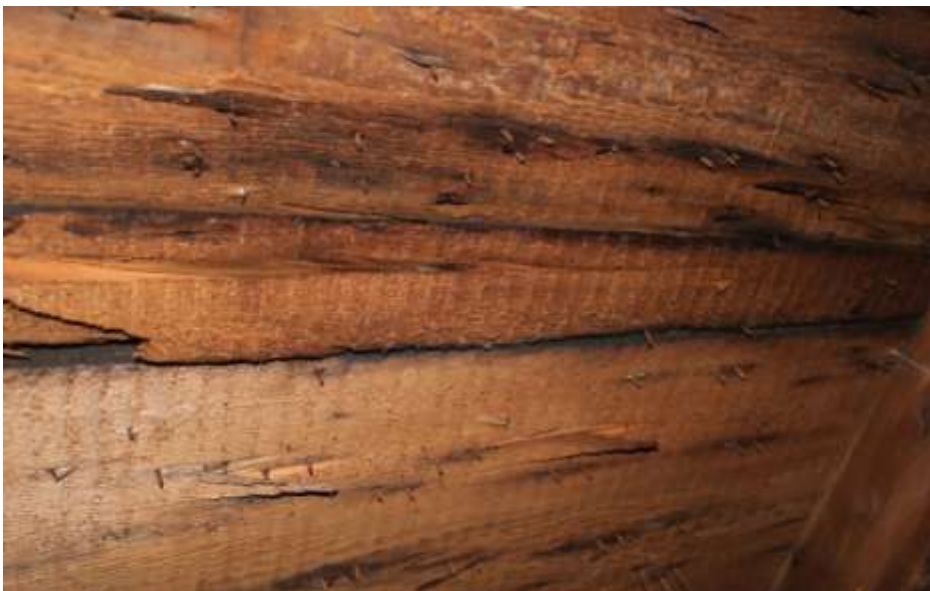
The schoolhouse sheathing is upright sawn, a technology that became more widely used in this area around the 1790s (Photo 34). Cut nails puncture the

Photo 34: Schoolhouse roof sheathing, upright sawn

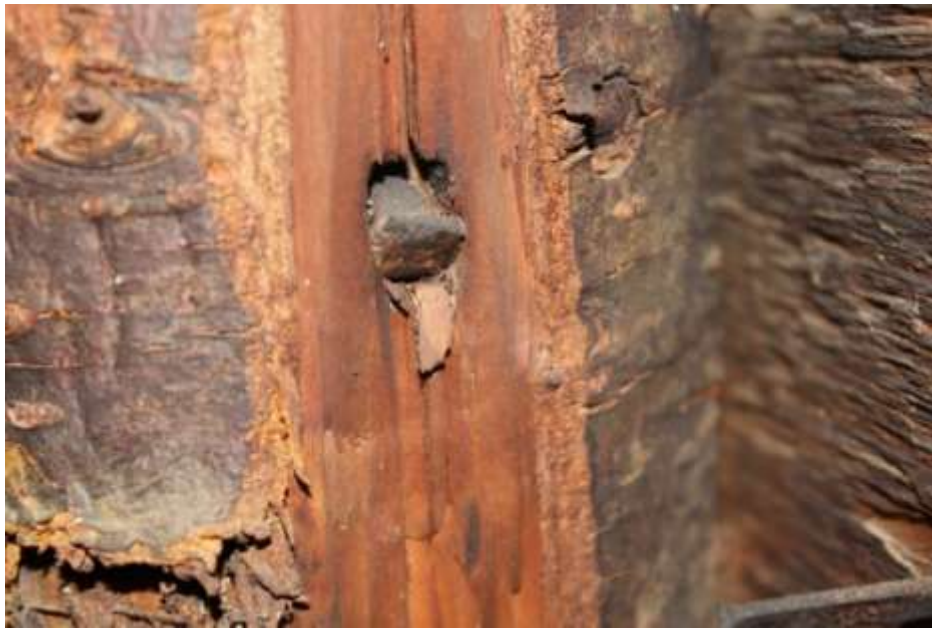
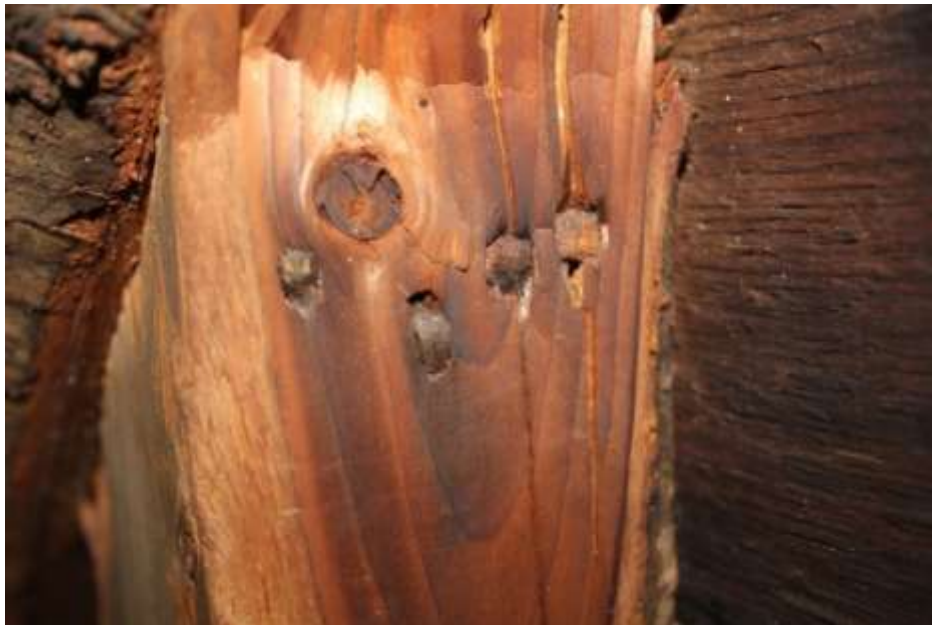
(Photos 34, 35). Cut nail technology was invented in the 1790s and spread rapidly.

Photo 35: Early cut nail in gable end stud

Photo 36: Wrought and cut nails in gable end stud

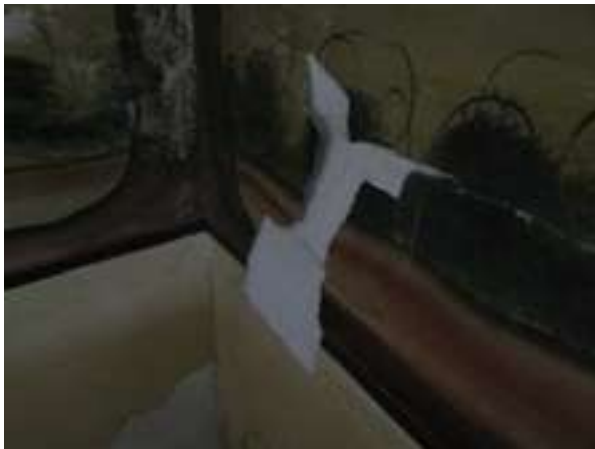
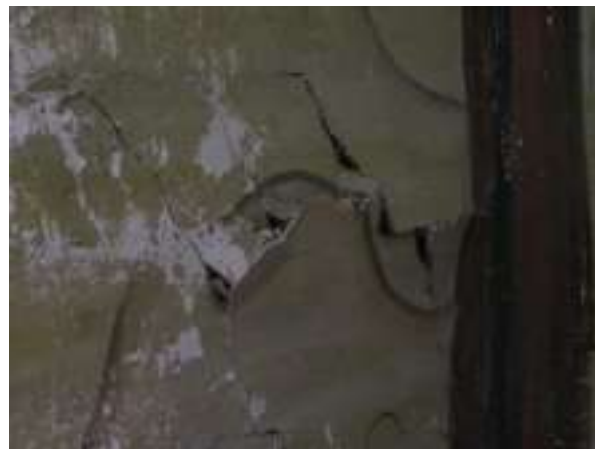
Most all of the plaster failure can be attributed to movement in the buildings structure. Water infiltration especially on the ceiling but also on the upper walls has also helped to weaken the plaster. ***Before any structural work is begun on the building all areas of plaster should be addressed for stability.*** Decisions will need to be made in conjunction with structural repair. At present there is substantial settling in both the north and south walls. When the members are replaced there will no doubt be

movement even if the plan is made to not straighten but rather to maintain the building in its present position. There are a few areas in particular that will not withstand even slight movement without some potential plaster loss. Two of these are at either end of the south wall shown above. Certainly all areas are not exempt from the possibility of loss during structural repairs. The structural repairs are necessary to prevent the continued movement and subsequent damage to the plaster. Fortunately actual plaster loss to date is primarily limited to that shown above and that removed to install electrical outlets in the east wall shown at right.

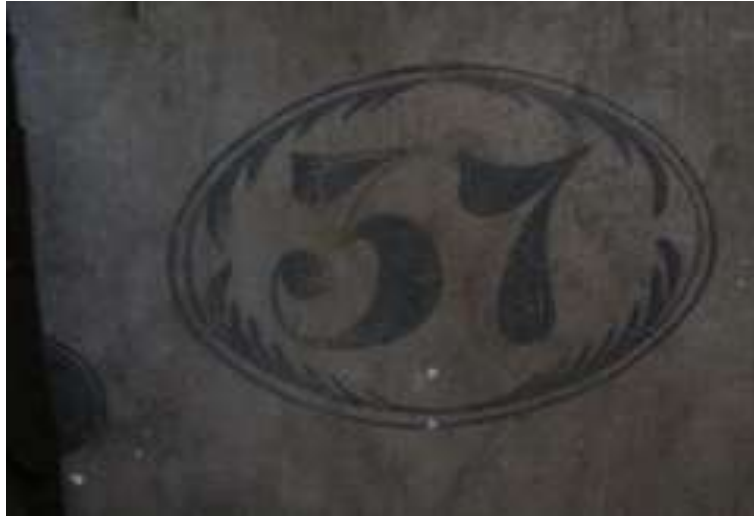
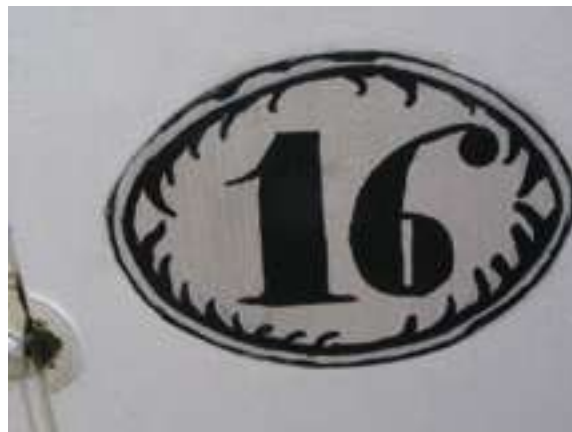
The trim paint in the sanctuary has been overpainted. There are two removed pew doors that still have their original color and details. As can be noted in the images to the right, the original numbering of the doors was executed by a much more refined hand. Consideration should be given as to whether it would be appropriate to bring the color and numbering back to an accurate representation of the original or to leave the changes as part of the rooms 'story', and display the original doors as a tribute to the original.

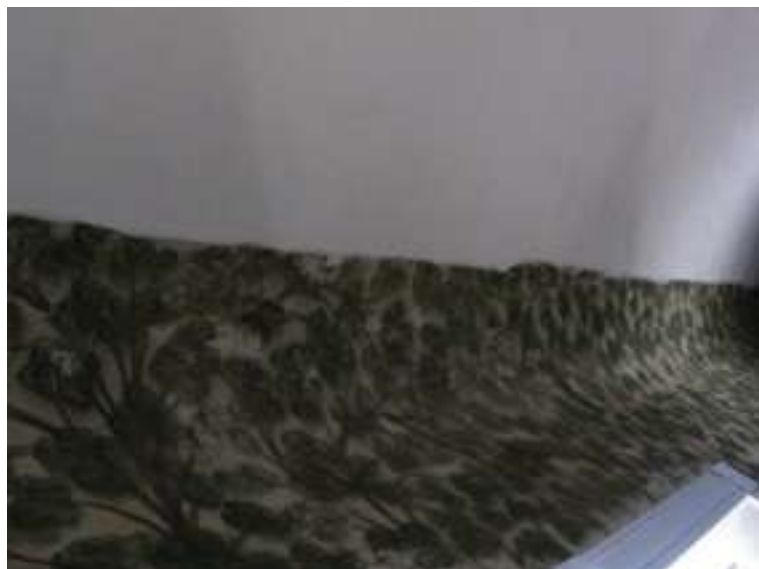
The ceiling paint is also not original. Unfortunately it was applied onto the upper part of the mural. The tops of the trees no doubt had a much softer and more organic line and may have gone even several inches further up the cove between the wall and ceiling. The original ceiling color was most likely the same as the lightest sky behind the trees at the top of the murals. See image at right...

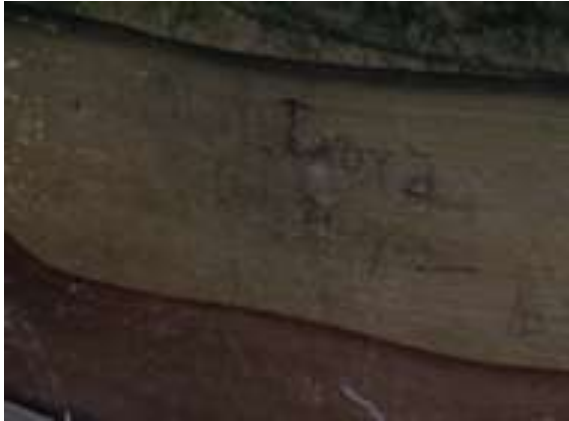
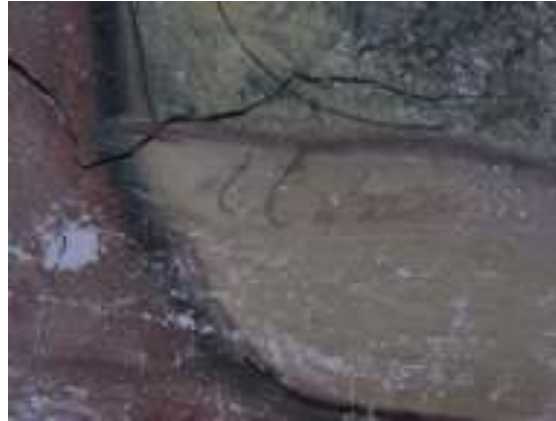
There are numerous signatures and other comments marked around the base of the murals in pencil or by scratching. These too are a part of the story and all should be preserved. Two areas are shown below.
